Exhibit R

Materials Characterization of Explanted Polypropylene Hernia Meshes

C. R. Costello, 1 S. L. Bachman, 2 B. J. Ramshaw, 2 S. A. Grant 1

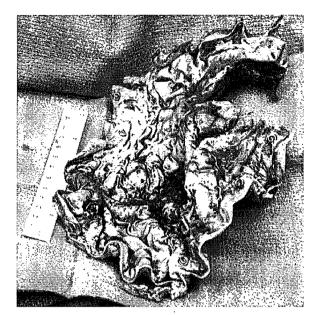
Figure 1. Kugel Composix hernia mesh immediately after explantation.

Polypropylene hernia repair materials were removed from patients requiring revision surgery due to chronic pain, recurrence, infection, adhesions, or other complications. An example of an explanted mesh is shown in Figure 1, and the contraction and embrittlement of the material are evident. The study was approved by the University of Missouri-Columbia's IRB committee, and each explant was given a sequential specimen number unrelated to any identifiable patient data. All 14 samples included in this study were the polypropylene components from polypropylene/expanded polytetrafluoroethylene composite hernia mesh such as Composix E/X or Kugel Composix (C.R. Bard, Cranston, RI), shown in Figure 2.

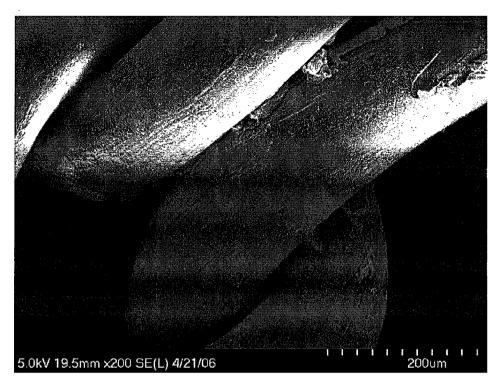
such as cracks or fissures. Conversely, as shown in Figures 5–7, the explanted polypropylene specimens appeared badly degraded, including cracks, fissures, and increased surface roughness. Micrographs of 79% of all explanted specimens exhibited cracks in the transverse or longitudinal direction, 57% showed what appeared as a peeling of the fiber surface, and 64% displayed a rough, blistered surface. Overall, 85% of the explanted specimens possessed at least two or more of these types of surface structures.

The SEM micrographs displayed images of materials that were vastly different in topology than the pristine materials. The micrographs of explanted polypropylene materials exhibited cracks, surface roughness, and peeling indicative of surface degradation, ^{6,10,12} while the pristine materials appeared smooth.

Figure 7. SEM of an explanted polypropylene mesh with "peeling" fibers.
